**MARYLAND HISTORICAL TRUST  
DETERMINATION OF ELIGIBILITY FORM**

Property Name: Stoopley Gibson (Whites Heritage) Inventory Number: QA-222

Stoopley-Gibson (White's Heritage), QA-222  
Chester, Kent Island, Queen Anne's County, Maryland  
Rebecca Howell, 8/25/2006

### Addendum Section 3

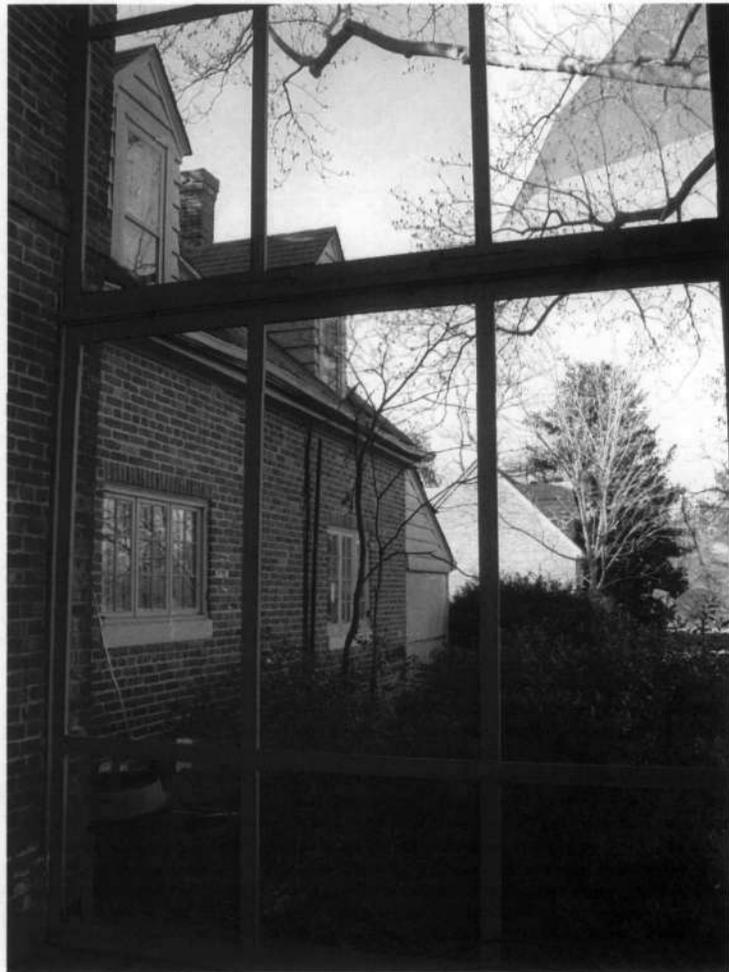
Photo 30:

View facing east from north porch.

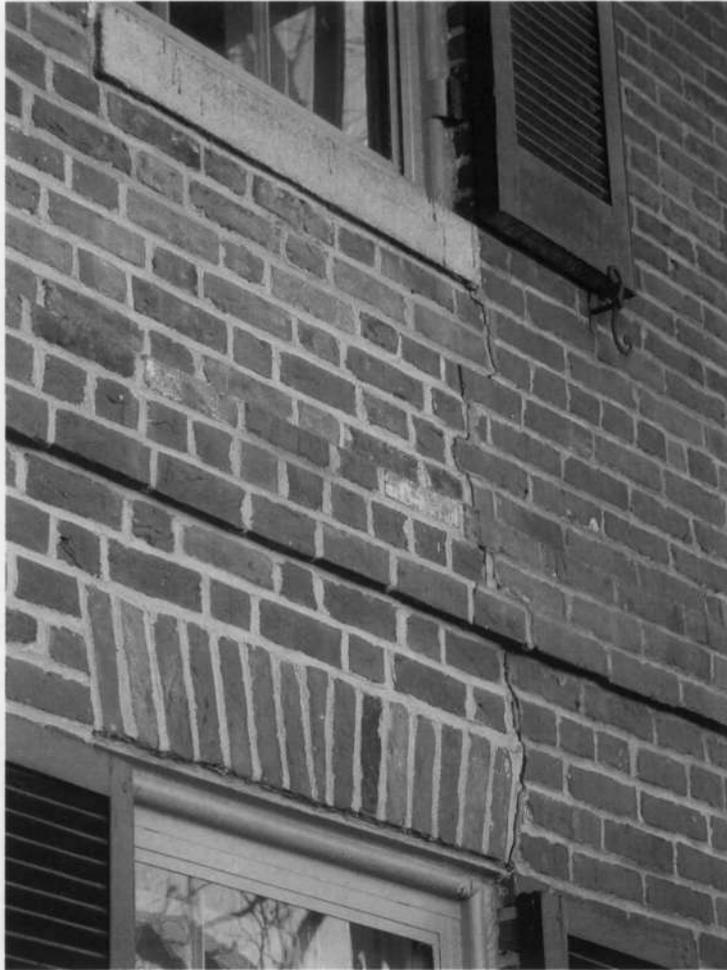
Photo 31:

Detail of north façade; crack in masonry between windows to west of door.

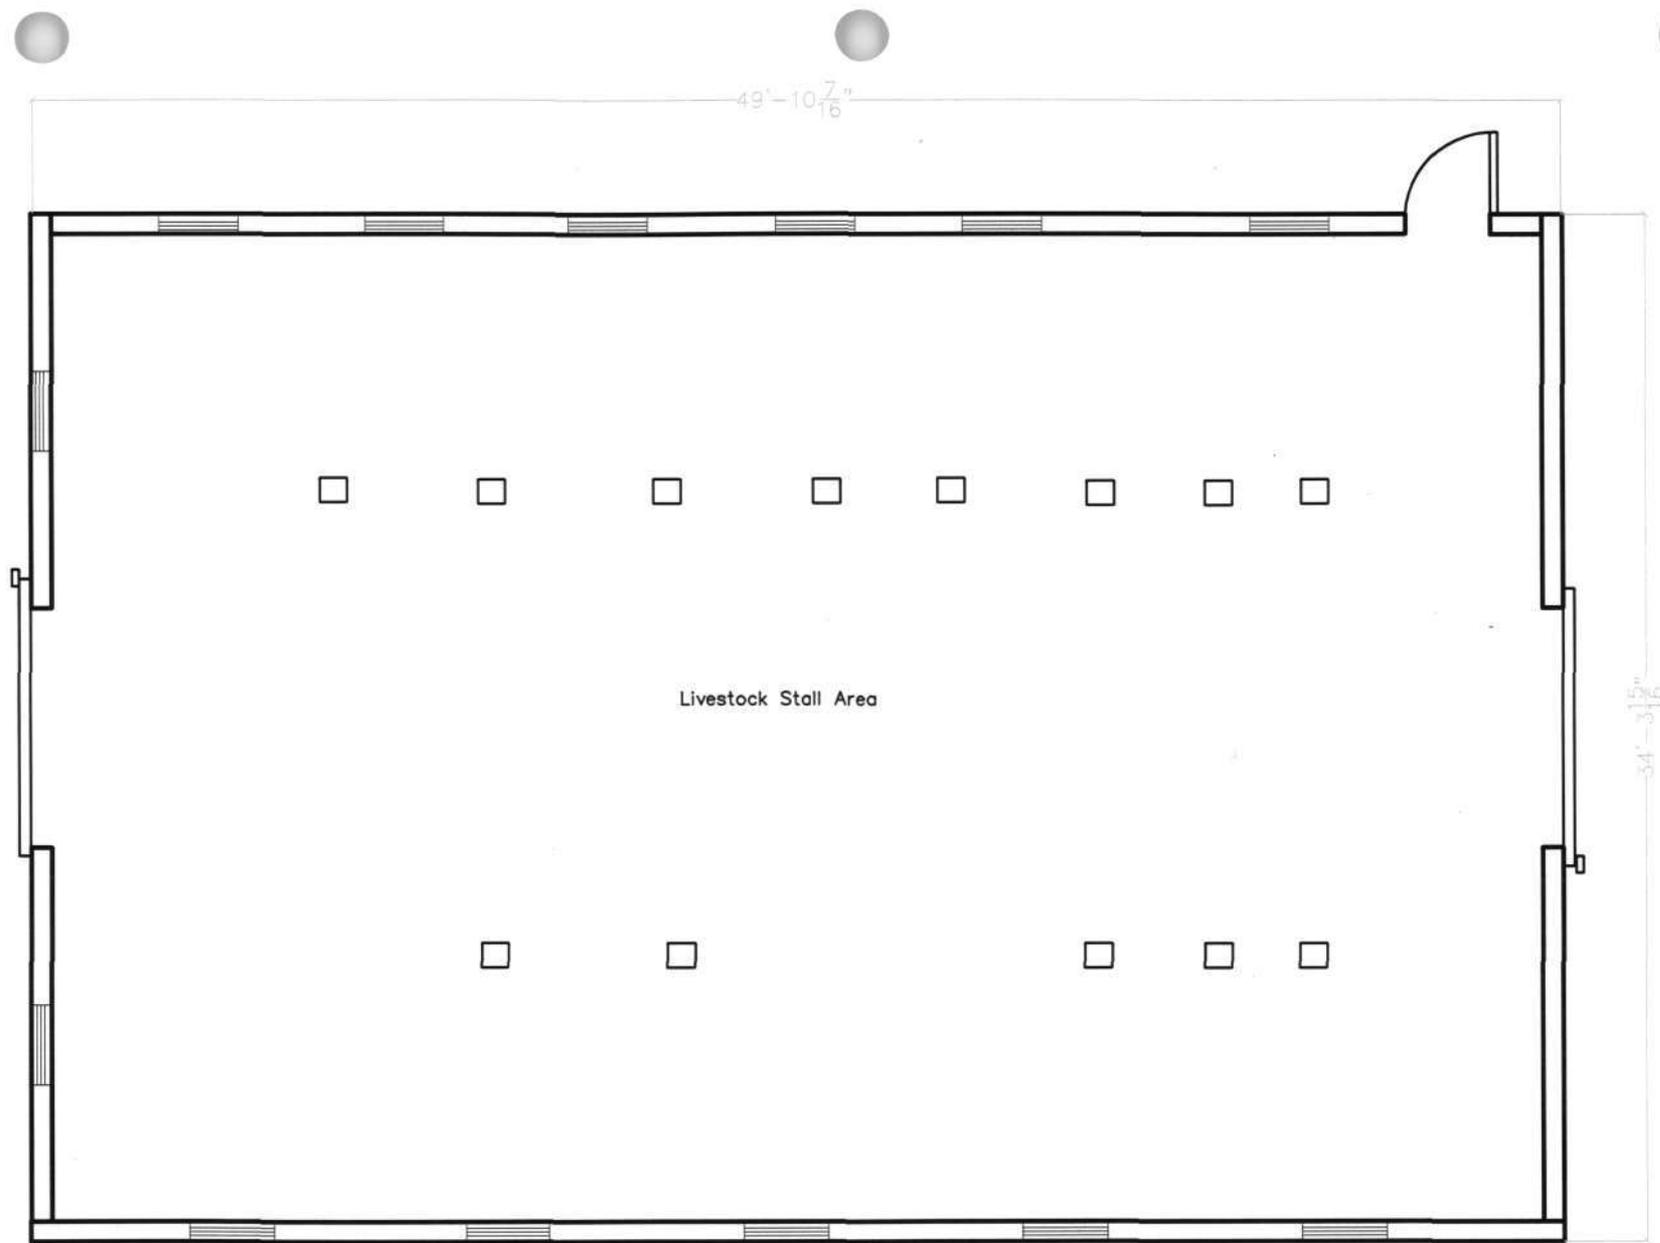
White's Heritage- OA-222 West Barn

The larger barn or West Barn has a gambrel roof running east and west. It has frame construction and a poured concrete foundation and floor. It has dimensions 36'6" by 68' or 49' by 68', when including the width of two silos and a stair hall wing located on the north side. The silos are cylindrical and flank the stair hall wing to form a symmetrical north façade. The stair hall wing has a gambrel roof and is two stories in height. The main portion of the barn is equivalent to three-and-a-half stories in height. The ground level is divided into livestock stalls by metal poles and metal fencing, and it has eight windows framed in metal on each the north and south sides. Troughs in the concrete, measuring about a foot wide and six inches deep, separate each stall from the central passageway. Double sliding doors form vehicular sized entrances at the east and west ends of this passageway, and a window is located on each side of these entrances. The north side has a wood door that leads to the stair hall wing, which has access to each of the two silos and to the exterior. Wood stairs lead to the second level of the stair hall wing and to the hay loft, in which the framing of the barns is visible. The east and west walls of the loft have two levels of entrances for hay storage and removal, a double set of door at the top, and a single wood door below. Two small dormers containing three windows each are located on the north and south facades near the top of the gambrel roof. The style of the West Barn is typical of a dairy barn from the first half of the twentieth-century, incorporating modern agricultural technology and materials.

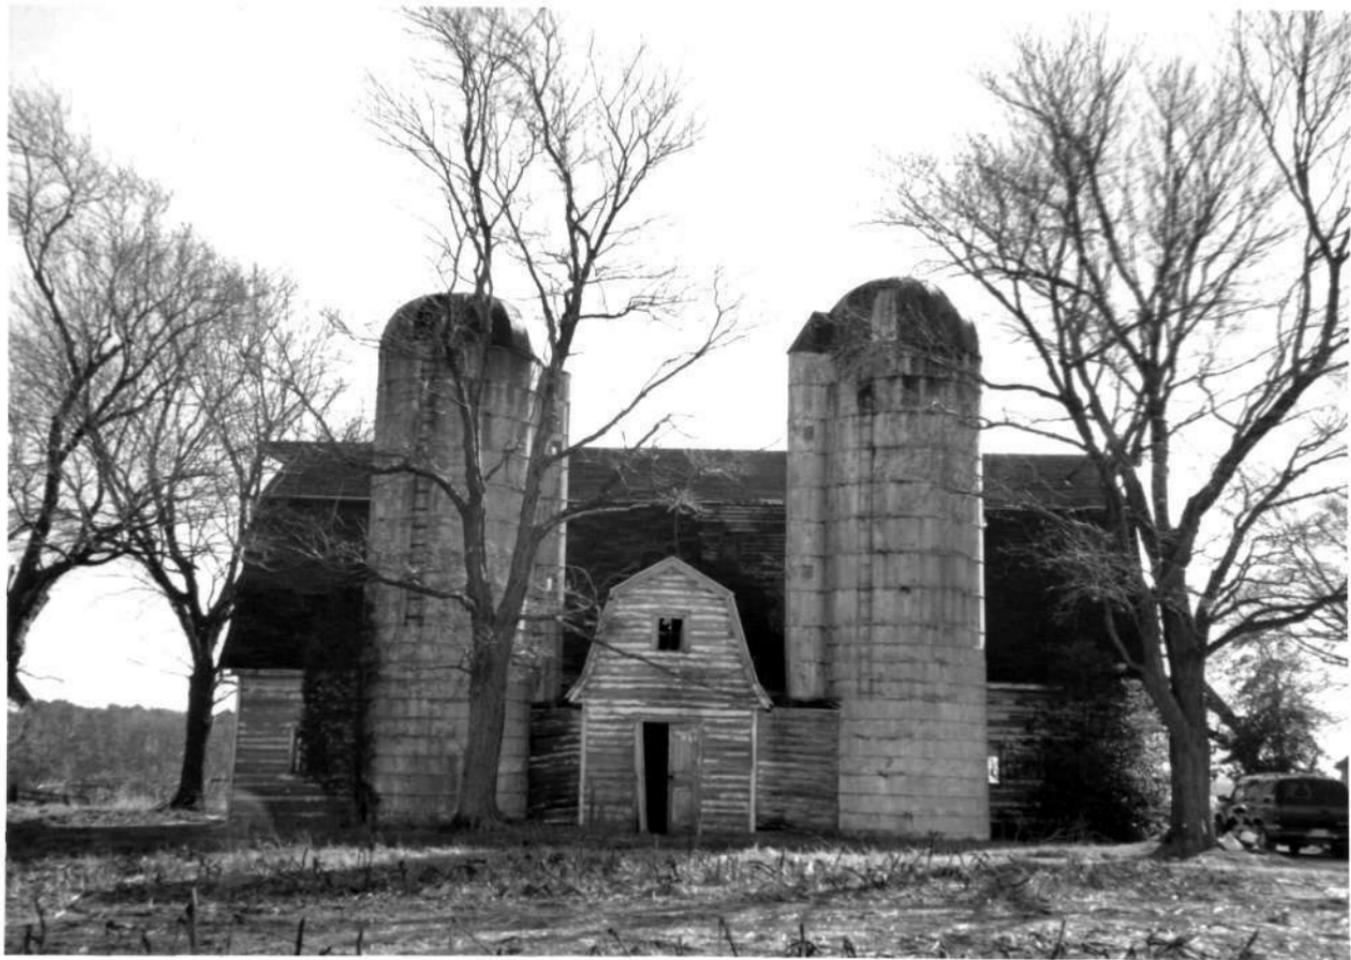
# 1 of 14

West barn, north facade

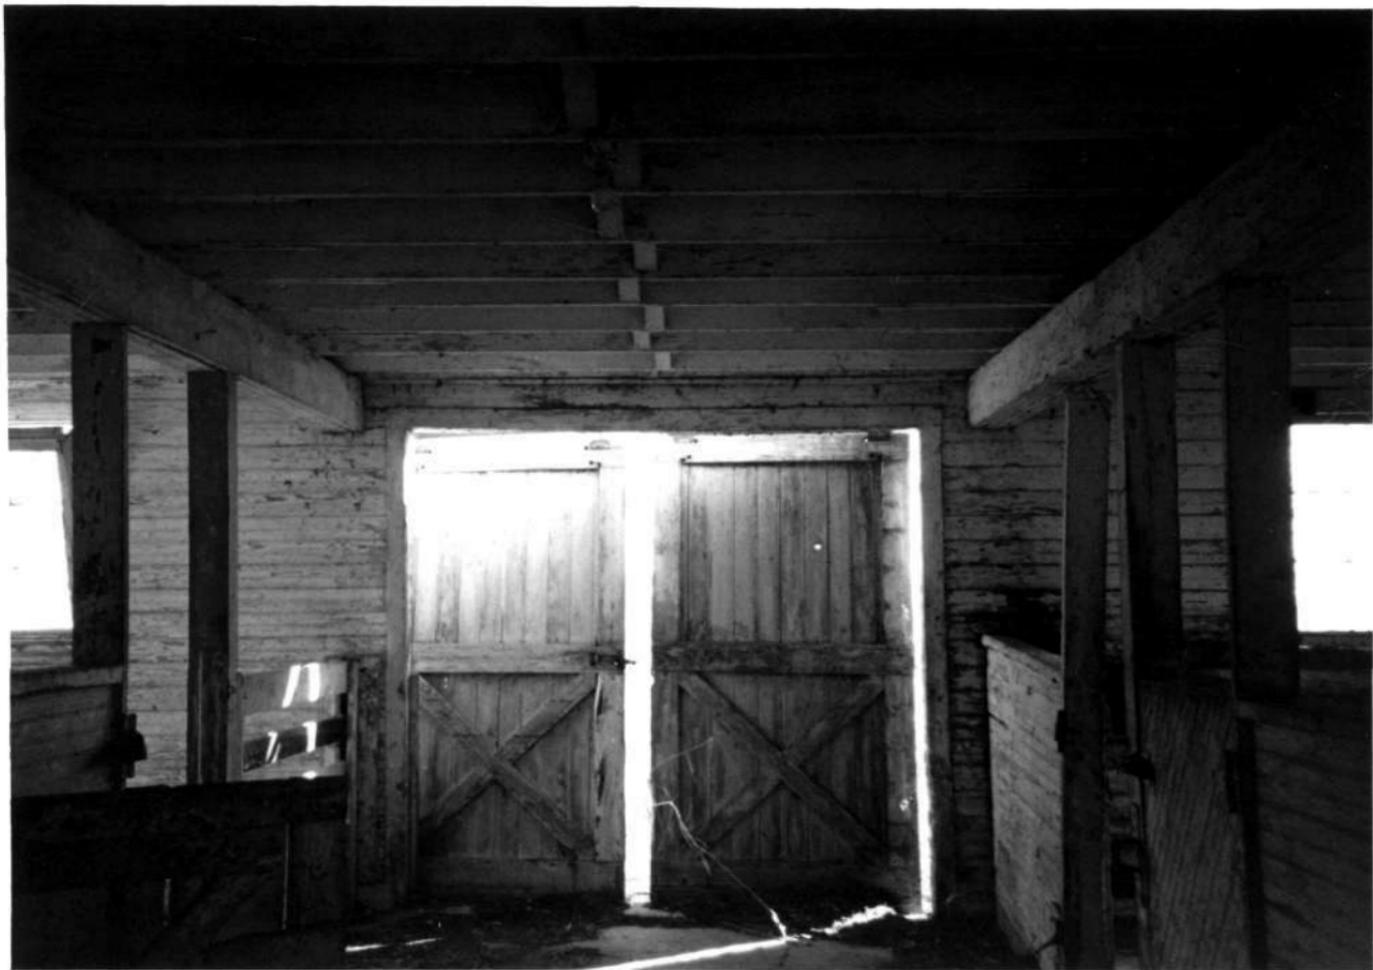
# 5 of 11

East barn, South wall (interior)

The smaller barn, or East Barn, seems to slightly pre-date the West Barn. It is orientated running north and south and has dimension of about 34' by 50', with a height equivalent to about three stories. It is frame, with a gambrel roof and a concrete foundation. Sliding double doors on the north and south ends create a passage through the first level of the barn. The openings are flanked by nine-light windows. Livestock stalls are divided by wood frame dividers and gates. The east side of the barn has five windows with nine lights each; this half of the barn has a full frame partition at the south end. The west side of the barn has five windows (three with six lights and two with nine lights) and a small (about 4' high) exterior door. The loft is accessible from the interior only by a ladder and from door-size openings on the north and south gables. Asphalt shingles cover the roof, and there is a large hole in the roof, at the south end of the west side. Some of the windows are missing on the first floor of the barn. The windows are fit into the barn with metal frames like in the West Barn, but that is the only use of metal in the building, suggesting, along with the smaller size, an earlier construction date.

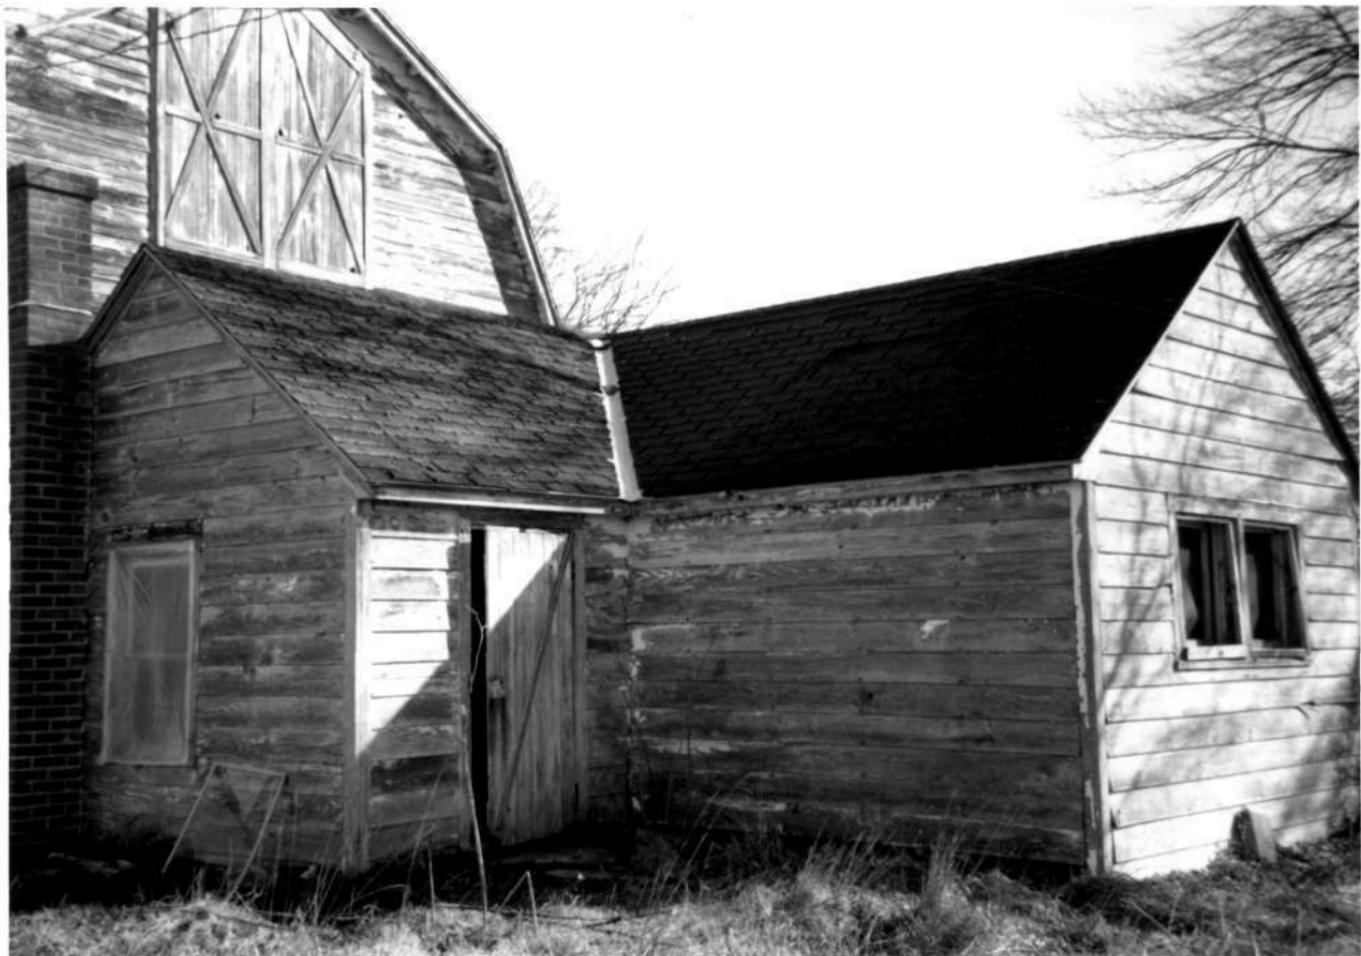
# 8 of 11

Farm office, north + west facades; west barn in background

The ell-shaped frame office is diminutive in scale compared to the adjacent barn. It has a poured concrete foundation and two gable roofs intersecting at the southeast corner. There is a brick stove chimney on the north end of the building, located off-center of the north gable. A six-over-six window is centrally located under this gable. Viewing from the west shows one door on the recessed portion and one window under the extended gable portion. The flat south façade has two entrances: one under a gable and one under the east-west running portion of the roof. The flat east façade has one six-over-six window.

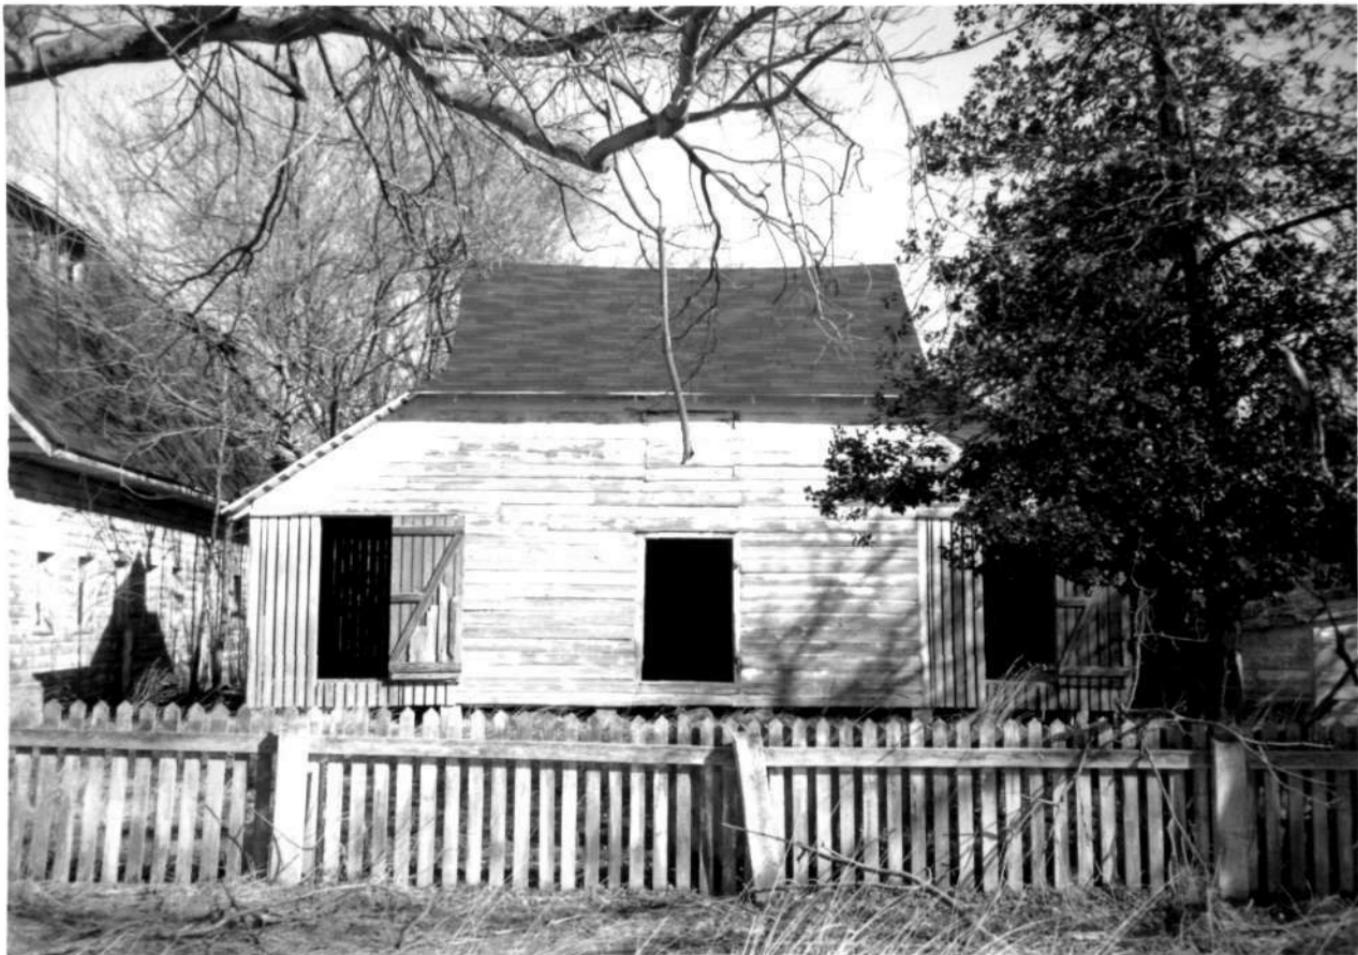
# 9 of 11

Corn crib, west facade

The corn crib is built on concrete piers and is constructed with a one and a half story middle section and two sides, creating three chambers. The central chamber has a gable roof that runs north and south. Each side chamber has a shed roof that meets the wall of the exterior wall of the central chamber at the bottom of the gable roof. The siding for each side chamber is perpendicular to the ground, while the central chamber has regular clapboard siding. Each chamber has a door located on the west side. The corncrib is located south of the West Barn and north of a chicken coop.

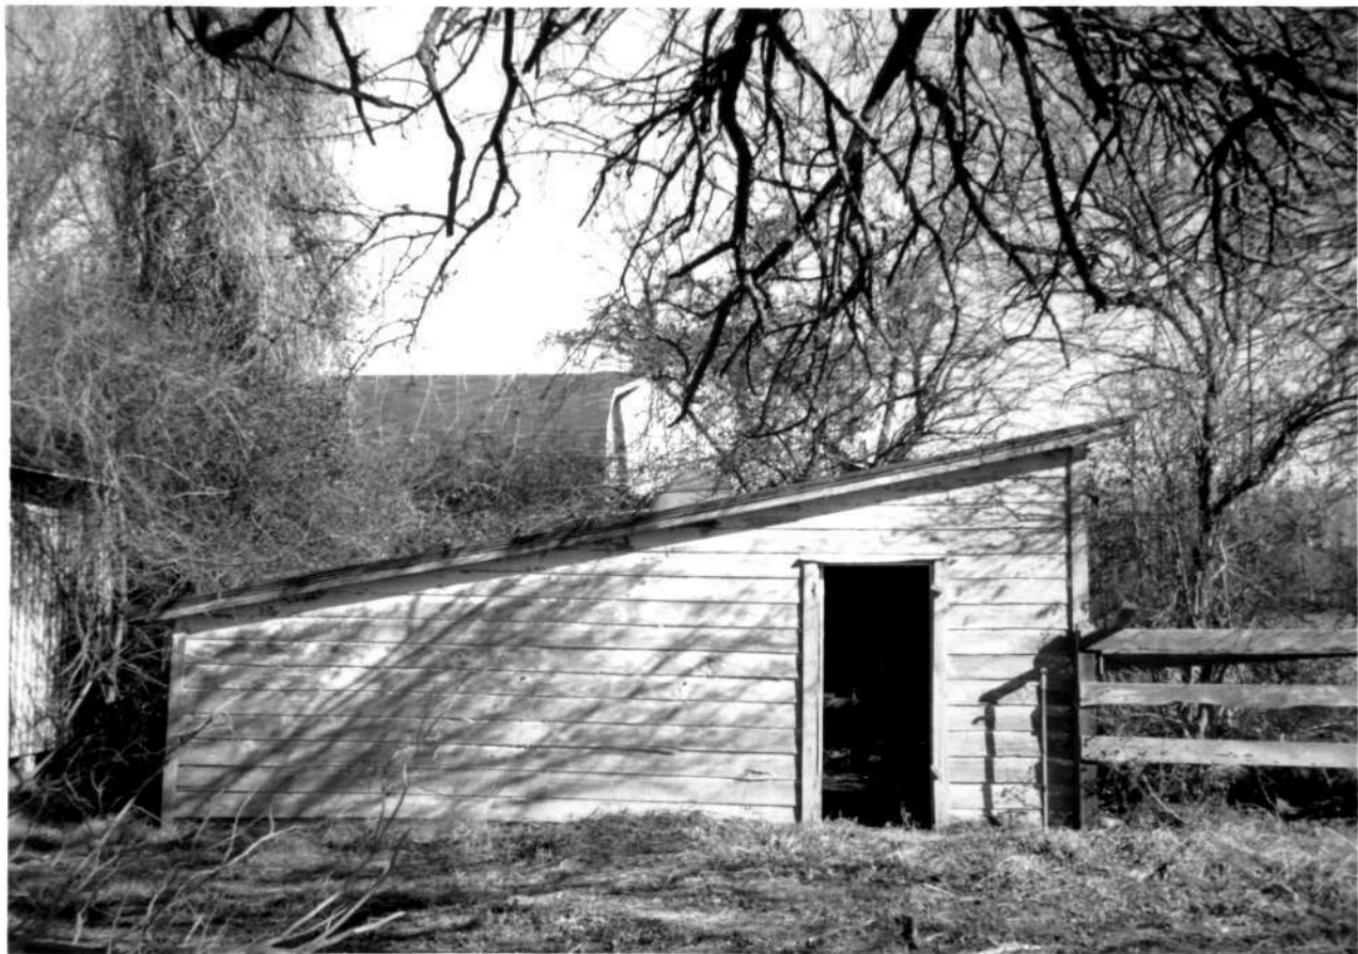
# 10 of 11

Chicken coop, west facade; east barn in background.

The frame chicken coop has a shed roof that is higher on the south side. The entrance to the inside is located at the south side of the west façade. Inside, there is a dirt floor and built in shelves on the north and east walls. A horizontal window opening, covered with chicken wire is located along the south façade. There is a fence running from the south
